LIGHTNING TECHNOLOGIES, AN NTS COMPANY

**Lightning Direct Effects High Current  
Arc Entry Tests on Corrugated Stainless  
Steel Tubing (CSST) Samples and  
Lightning Detection/  
Gas Flow Meter Detector**

Issue Date: 22 November 2013

Project No. PR024722

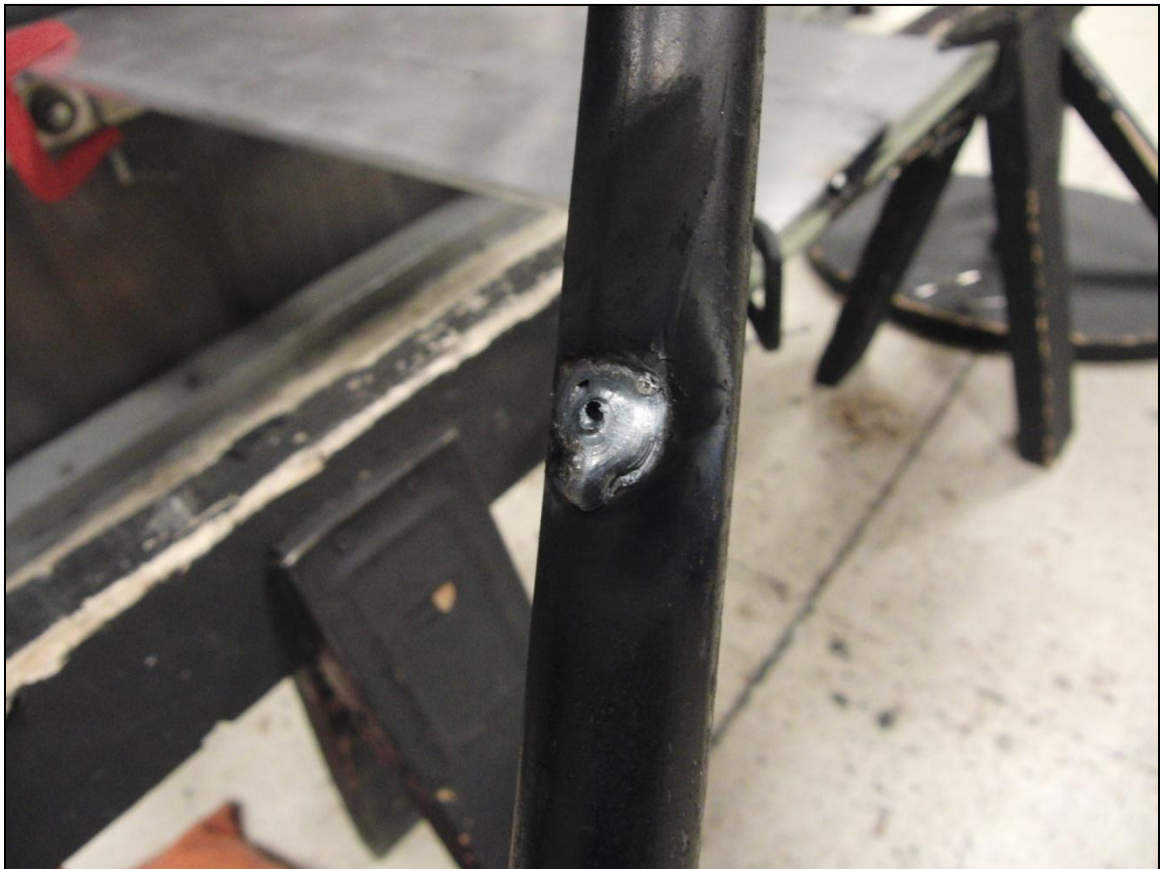
Figure 8 – Post-Test Photograph, Test No. 1

A black iron pipe was tested with LC10127 Components 1-3 which resulted in at least a melting around the area of test. Goodson Engineering will provide the complete results of this test. Next, a 1" diameter CSST was tested which resulted in the CSST splitting in two and ignition of the yellow jacket that was manually extinguished, post-test. A lightning detection/gas flow meter detector unit was then tested with Component 1 which resulted in the unit shutting off the gas supply prior to internal failure. The last test included the application of Components 1 and 3 (with additional coulomb content to compensate for the lack of Component 2) to a FlashShield™ sample. Damage was observed of the outer jacket, but no damage to the CSST.

Test No.	Component 1		Component 2		Component 3			Notes/Results
	I <sub>pk</sub> (kA)	Action Integral (x10 <sup>6</sup> A <sup>2</sup> s)	I <sub>pk</sub> /I <sub>av</sub> (kA)	Charge in 5ms (C)	Duration (ms)	Total Charge (C)	Average Current (A)	
<i>4 November 2013</i>								
1	31.0	0.05	3.94/2.08	10.4	582	288	495	Tested Black Iron Pipe; Melted Exterior at Test Area; Complete Results will be Provided by Goodson Engineering
2	33.4	0.06	3.94/2.06	10.3	586	264	451	Tested 1" CSST #1; Article Cut in Two; Portion of CSST Vaporized
11	32.8	~0.05	Not Applied					Tested Lightning Detection/Gas Flow Meter Detector Unit; Unit Shut Off Gas Supply before Failing Internally; Waveform went Off Scale (Action Integral is an Estimate)
12	32.8	0.063	Not Applied		406	139	56.4	Tested FlashShield™ Sample; Additional Charge transferred by Component 3 to Compensate for Lack of Component 2; Damage to Outer Jacket but No Damage to CSST

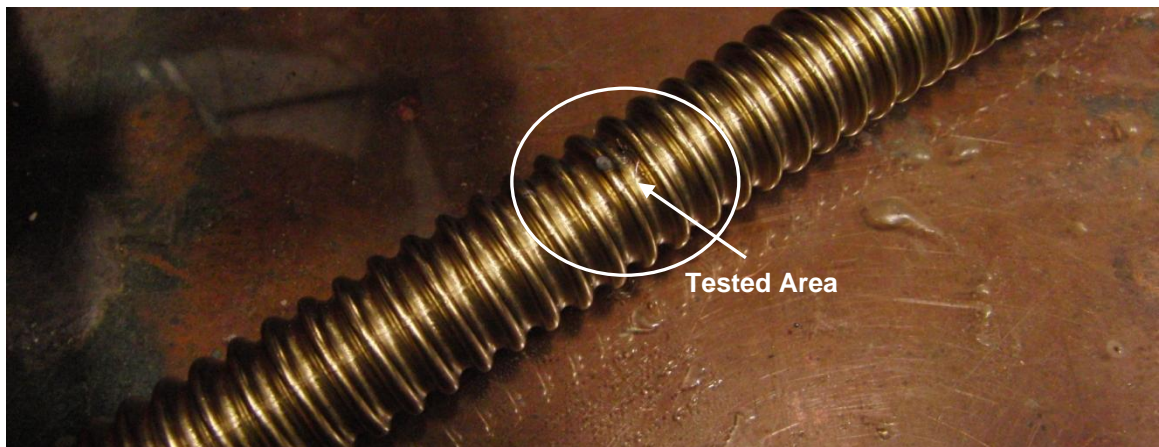
Figure 11 – Post-Test Photograph, Test No. 7

CSST #2 was tested twice with faults detected at ~1,300 A and 640 A. An unjacketed CSST sample was tested at first at a low level (304 A) which resulted in no formed hole. Then, it was tested at 1,760 A which did result in a hole. Lastly, a 3/4" Counterstrike™ sample was tested at 1,430 A which resulted in a slight crack in the jacket, but no hole. The second test to the 3/4" Counterstrike™ sample was performed at 1,710 A with the jacket intentionally pin pricked prior to test. This test resulted in a hole formed in the jacket and CSST.

Test No.	Applied Current		LD/GFD Present (Y/N)	Notes/Results
	I <sub>pk</sub> (A)	Charge (C)		
3	~1,300	--	Y	Tested CSST #2; Fault Detected; Waveform Went off Scale; Hole in CSST Jacket
4	640	2.56	Y	Second Test on CSST #2; Fault Detected; Hole in CSST Jacket
5	1,570	6.24	Y	Tested Unjacketed CSST Sample; Sample had Inadvertent Ground; Invalid Test
6	--	--	Y	Tested Unjacketed CSST Sample; No Oscillograms Recorded; Hole Formed in CSST
7	304	1.3	Y	Tested Unjacketed CSST Sample at Low Level; No Hole formed in CSST
8	1,760	6.9	Y	Tested Unjacketed CSST Sample; Hole Formed in CSST
9	1,430	5.3	N	Tested 3/4" Counterstrike™ Sample; Slight Crack in Jacket; No Hole in CSST
10	1,710	6.7	N	Tested 3/4" Counterstrike™ Sample; Jacket Pin Pricked Prior to Test; Hole formed in Jacket and CSST
